OPTIMAT BLADES

Preliminary tests Part 2

Static and fatigue tests of MD laminate with different gauge length

Research carried out by DLR within the framework of the Optimat Blades project
EC contract ENK6-CT-2001-00552

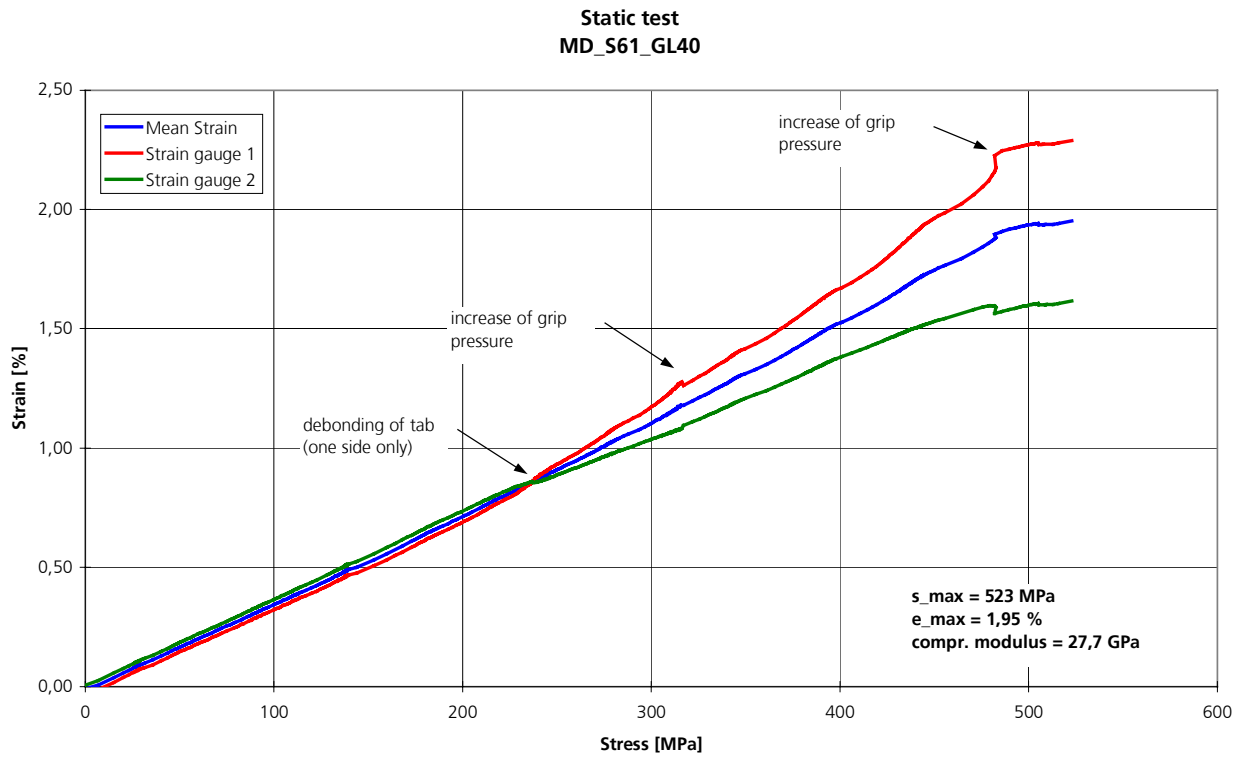
Figure 1: S61_GL40 - Strain gauge measurement, static test

| Test | F_{\max} [kN] | σ_{\max} [MPa] | ϵ_{\max} [%] | E [GPa] | Strain rate [%/s] | Cycles | Remarks |
|---|---|---|---|---|---|---|---|
| S61_GL40 | -85,34 | -522,9 | -1,95 | 27,66 | ≈0,031 | - | Debonding of tabs, bending |

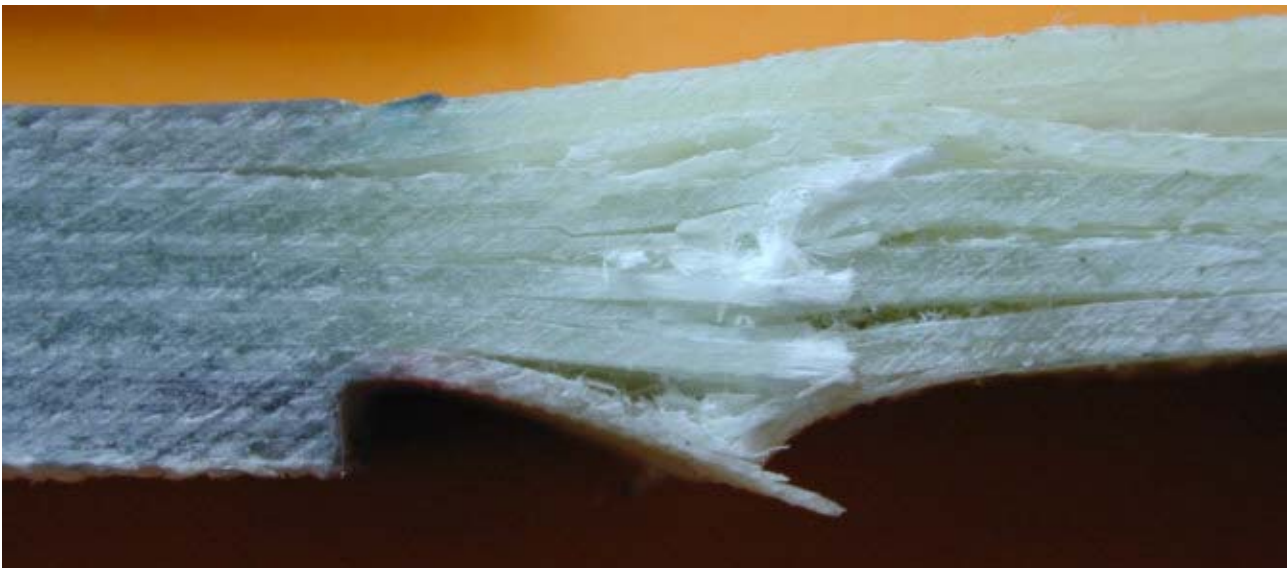
Figure 2: Specimen MD_S61_GL40

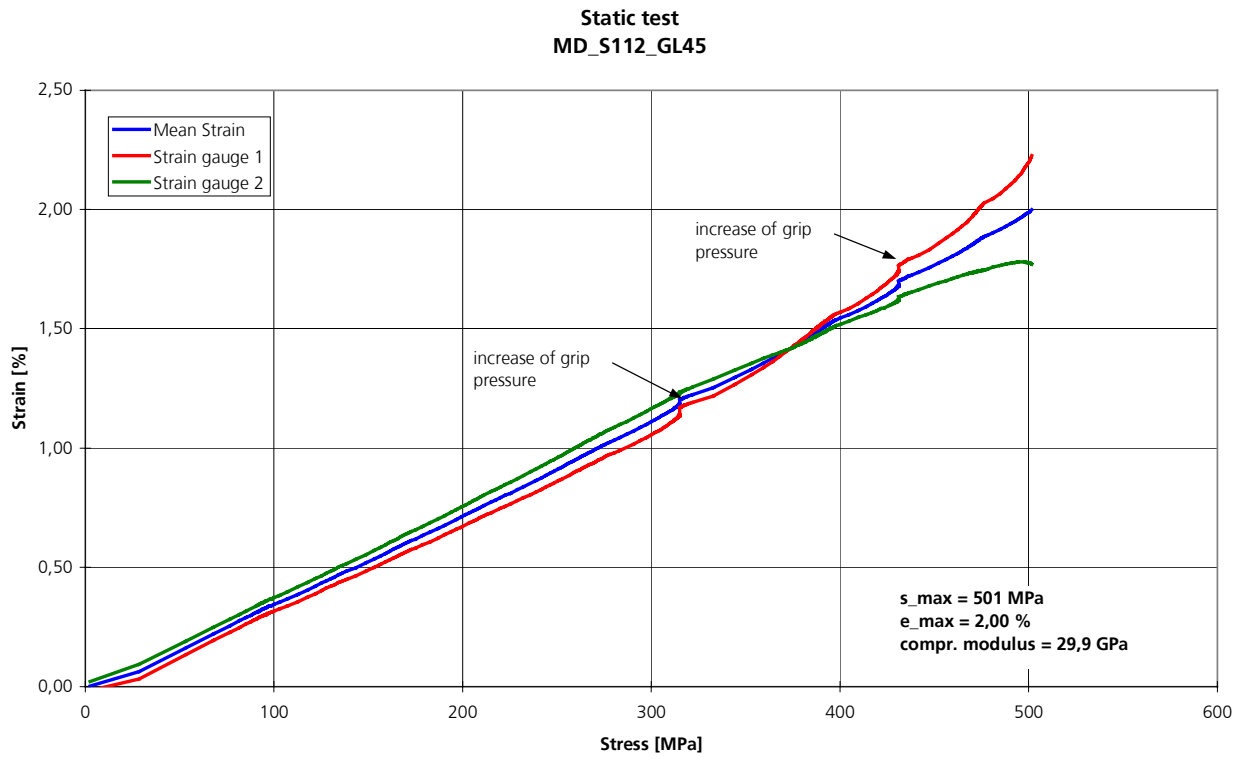
Figure 3: S112_GL45 - Strain gauge measurement, static test

| Test | F_{\max} [kN] | σ_{\max} [MPa] | ϵ_{\max} [%] | E [GPa] | Strain rate [%/s] | Cycles | Remarks |
|---|---|---|---|---|---|---|---|
| S112_GL45 | -82,54 | -501,7 | -2,00 | 29,90 | ≈0,043 | - | Bending |

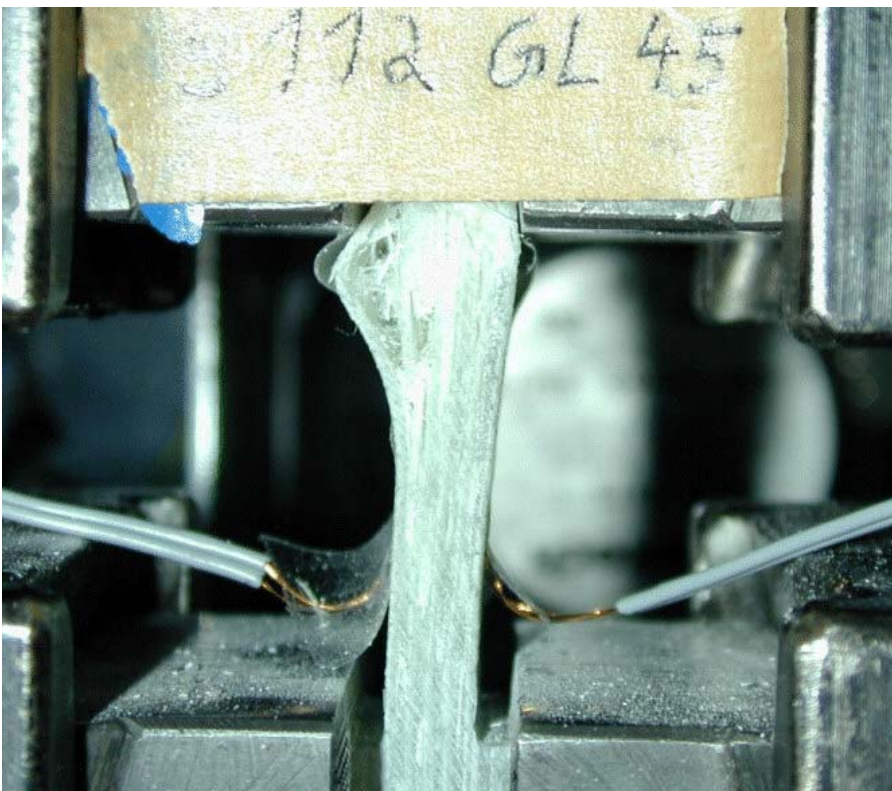
Figure 4: Specimen MD_S112_GL45

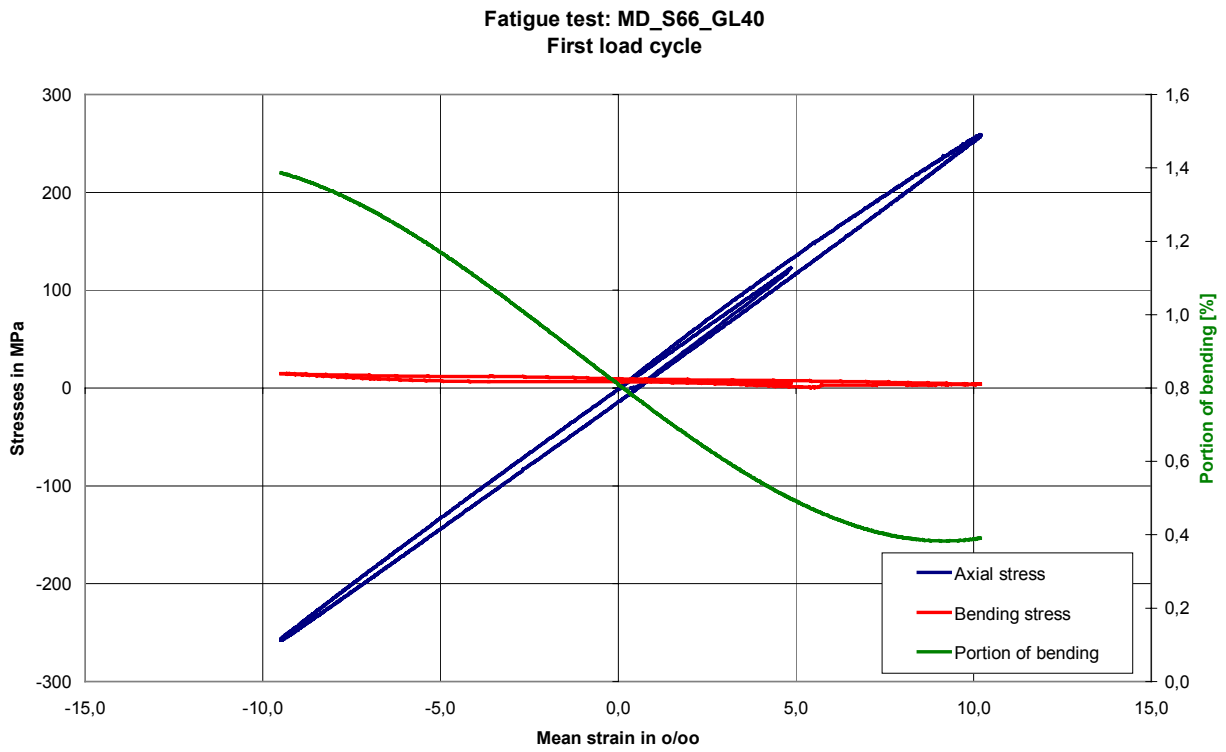
Figure 5: MD_S66_GL40 - Evaluation of bending

| Test | F_{\max} [kN] | σ_{\max} [MPa] | ϵ_{\max} [%] | E [GPa] | Strain rate [%/s] | Cycles | Remarks |
|---|---|---|---|---|---|---|---|
| S66_GL40 | ±42,4 | ±261 | +1,02 -0,95 | +27,9 -25,9 | 10,0 | 168 | Buckling |

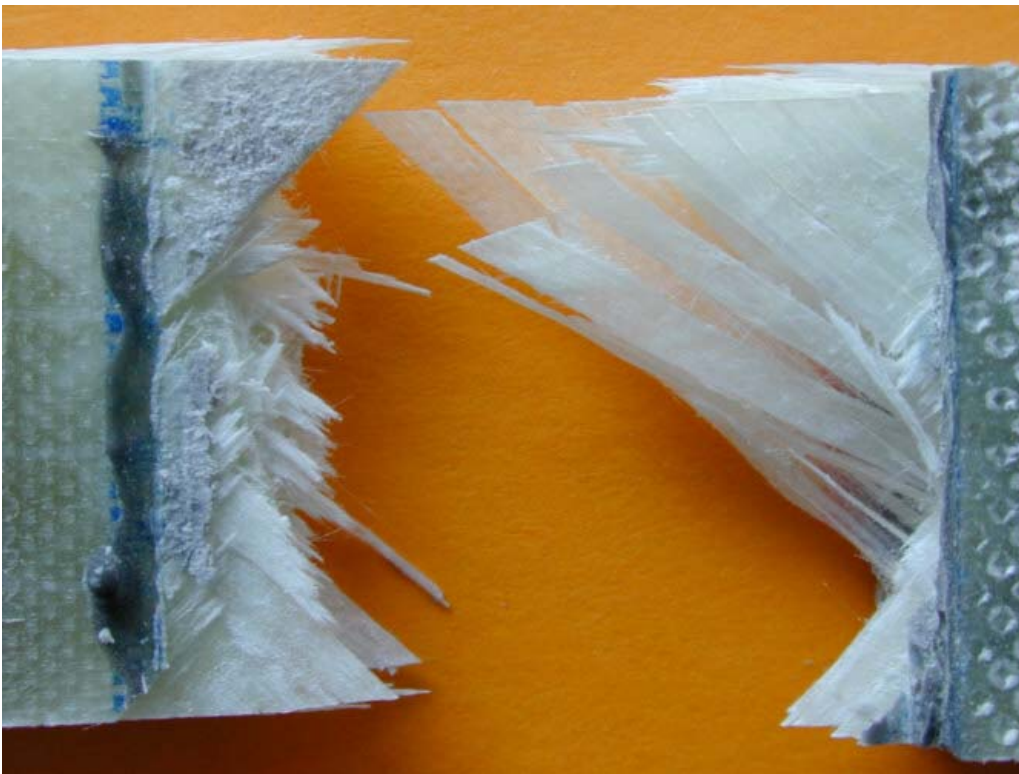
Figure 6: Specimen MD_S66_GL40

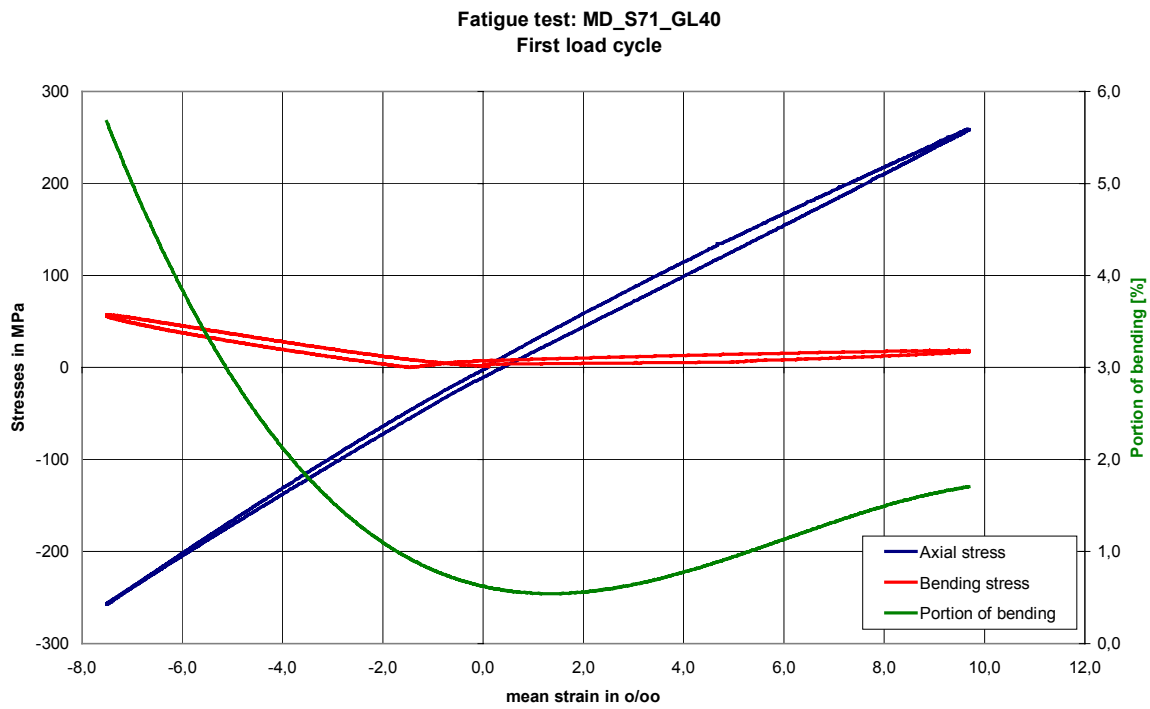
Figure 7: MD_S71_GL40 - Evaluation of bending

| Test | F_{\max} [kN] | σ_{\max} [MPa] | ϵ_{\max} [%] | E [GPa] | Strain rate [%/s] | Cycles | Remarks |
|---|---|---|---|---|---|---|---|
| S71_GL40 | ±41,8 | ±261 | +0,97 -0,75 | +29,1 -31,8 | 5,0 | 336 | Initial bending Severe buckling |

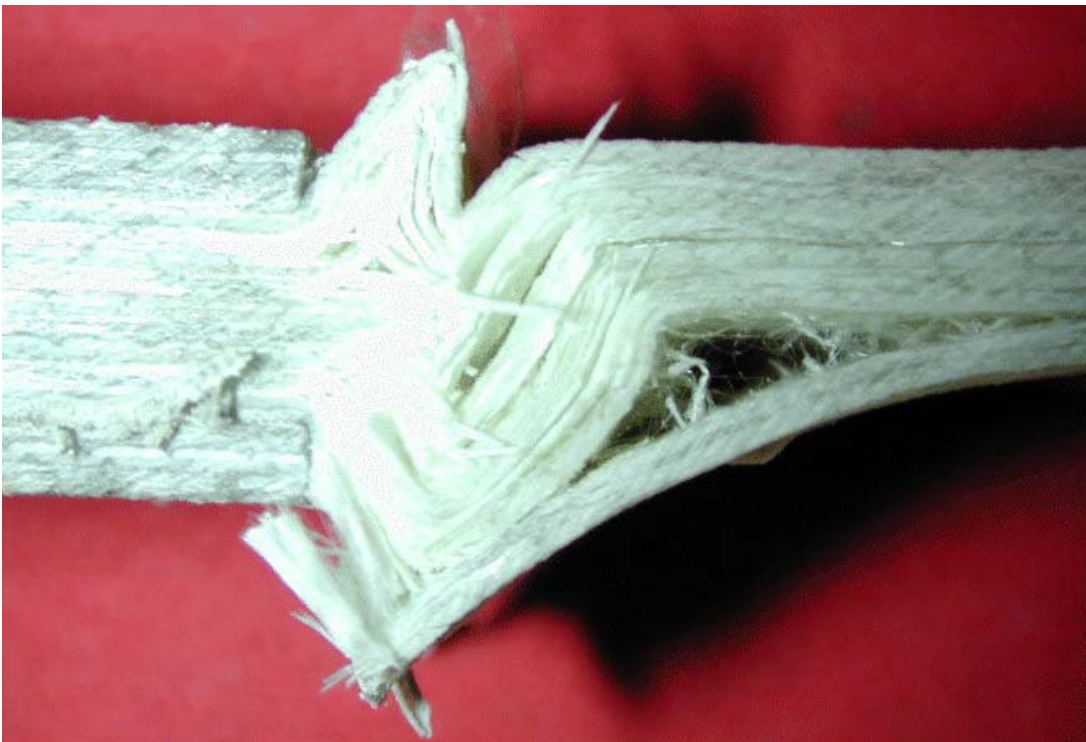
Figure 10: Specimen MD_S117_GL45

| Test | F_{\max} [kN] | σ_{\max} [MPa] | ϵ_{\max} [%] | E [GPa] | Strain rate [%/s] | Cycles | Remarks |
|---|---|---|---|---|---|---|---|
| S117_GL45 | ±32,89 | ±200 | +0,79 -0,74 | +27,4 -25,6 | 5,0 | 1897 | Severe buckling |

Since only a few specimen could be tested, the results don't allow any statistical evidence. But the presence of severe buckling for specimen MD_S117_GL45 already at a low stress level and low strain rate indicates that this gauge length is definitely too long.
